**Holchem Technical Centre Report**  
**Summary of Trials to Investigate the Potential Value of the**  
**Bactiscan in the Food Industry.**

Report Reference	TS 456	21/5/2012
Report Prepared by	David Whitehead Jim Taylour	Formulation Chemist Technical Manager
Approved by	Steve Bagshaw	Technical Director
On behalf of	Holchem Laboratories Ltd Premier House 175 Grane Road Haslingden Rossendale Lancashire. BB4 5ER Tel: 01706 222288 Fax: 01706 221550 Email: <a href="mailto:info@holchem.co.uk">info@holchem.co.uk</a> Web: <a href="http://www.holchem.co.uk">www.holchem.co.uk</a>

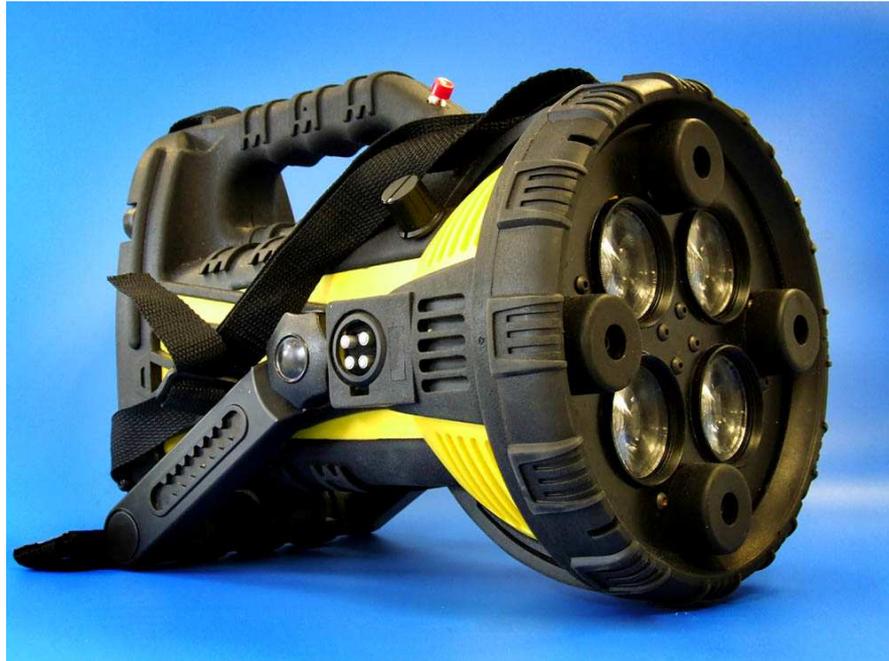
**Figure One**  
**The Bactiscan Unit**

Holchem were introduced to a technology produced by EIT International in late 2011. In brief, the technology consists of a lamp using light sources at three wave lengths. By use of these wavelengths independently or in different combinations, it is claimed that microbial contamination on surfaces can be visualised. There is also a facility to use a variable flicker rate for the light sources to enhance the revealing of organisms. Figure One is a picture of the lamp.

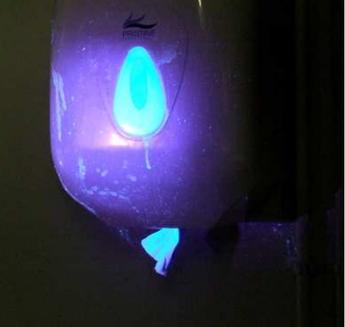
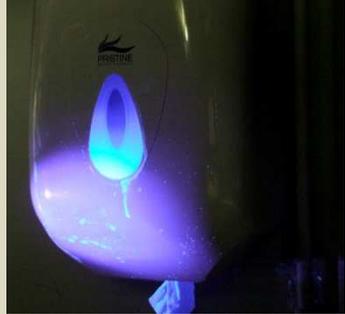
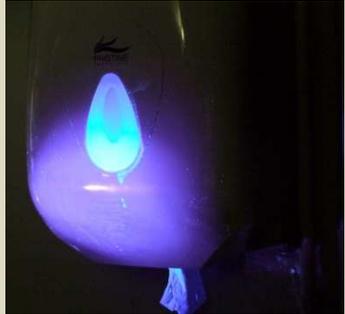
**Table Nine**  
**Towel Dispenser**

Location	ACC 22°C Cfu/swab	ACC 32°C Cfu/swab	ACC 37°C Cfu/swab	ATP/ RLU	Visualisation	
<b>Hospitality Area</b>						
Towel Dispenser Pre Clean Plastic surface No visible soil	0	1	0	440	Positive

Towel Dispenser Cleaned with K1 (Multipurpose Cleaner)	0	0	0	78	Positive

Towel Dispenser Cleaned with K2 Sanitiser (QAC Disinfectant)	0	0	0	51	Reduced

Data given in Table Nine shows a Towel Dispenser. Here the Bactiscan is we suspect creating a false impression. When initially inspected the unit appeared clean, but a positive hit was given under the Bactiscan light. ATP data was low, and subsequent swab data was insignificant. Sequential cleaning with **K1 Multi Purpose Cleaner** and **K2 Sanitiser** reduced the visualisation and indeed the apparent ATP and swab data. We think in this instance much of the material revealed by the Bactiscan was physical soiling and the low bacterial counts pose little health risk. However, there is clearly potential here for bacterial growth and in a high care environment such as a Care Home or Hospital, the Bactiscan may have benefit as an audit tool.
